# Manhole Inspection Summary

Manhole # S01AA2018MH

Insp Date: 11/1/06 10:40 AM

**Location** Address: **6201 PEARCE AVE**

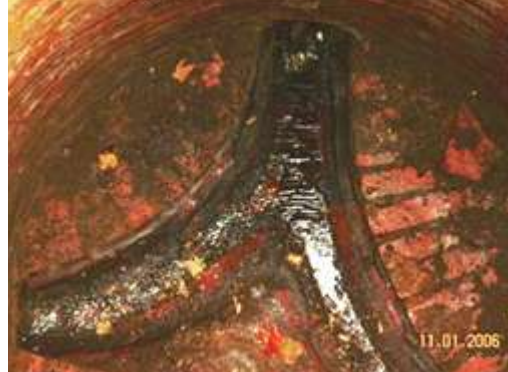
Top View

Evidence of surcharge - Bench debris.  
Channel debris.

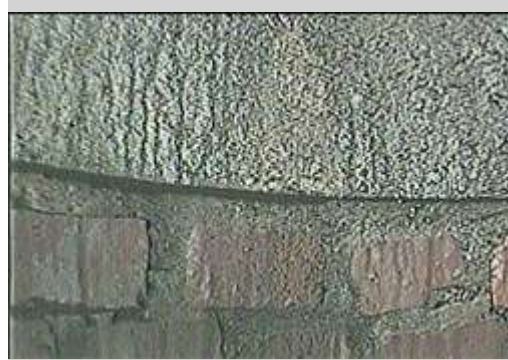
Defect

Frame leaks. Adjustment infiltration.

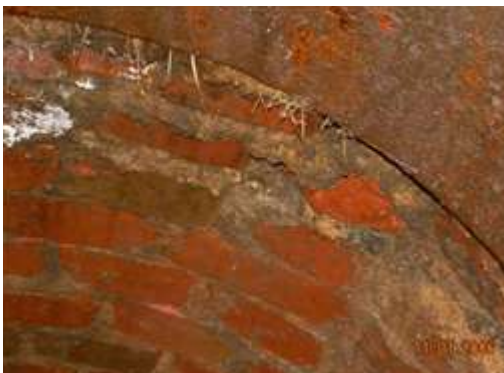
Defect

Frame leaks. Adjustment deterioration,  
root intrusion and infiltration.

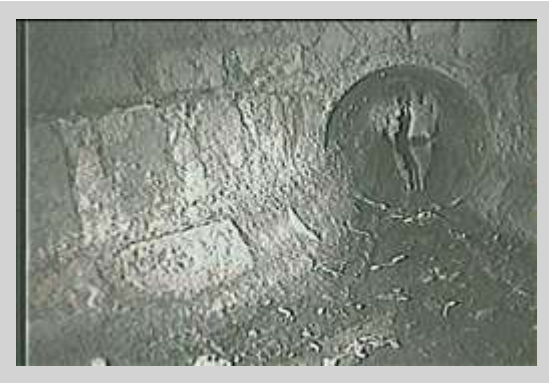
### 8 in. Circular Gravity Sewer Pipe Out @ 12 O'Clock

Barrel deterioration and infiltration.

Infiltration: **Evidence** Pipe Seal Cond: **Cracked**

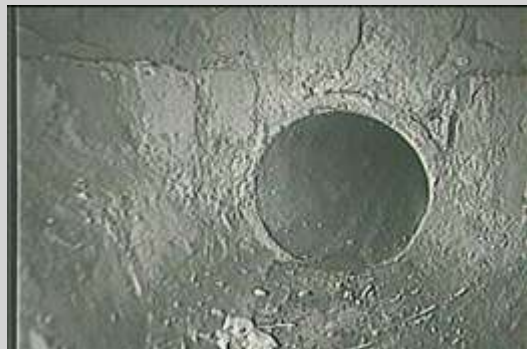
Pipe In @ 8 O'Clock

Infiltration: **Evidence**

Pipe Seal Cond: **Cracked**
